**TRANSPORTATION SCIENCES CENTER
ACCIDENT RESEARCH GROUP**

**CALSPAN ON-SITE AIR BAG DEPLOYMENT INVESTIGATION
CALSPAN CASE NO. 95-2
VEHICLE: 1994 FORD F-150 PICKUP TRUCK
LOCATION: [REDACTED] MS
CRASH DATE: [REDACTED] 1994**

SUMMARY

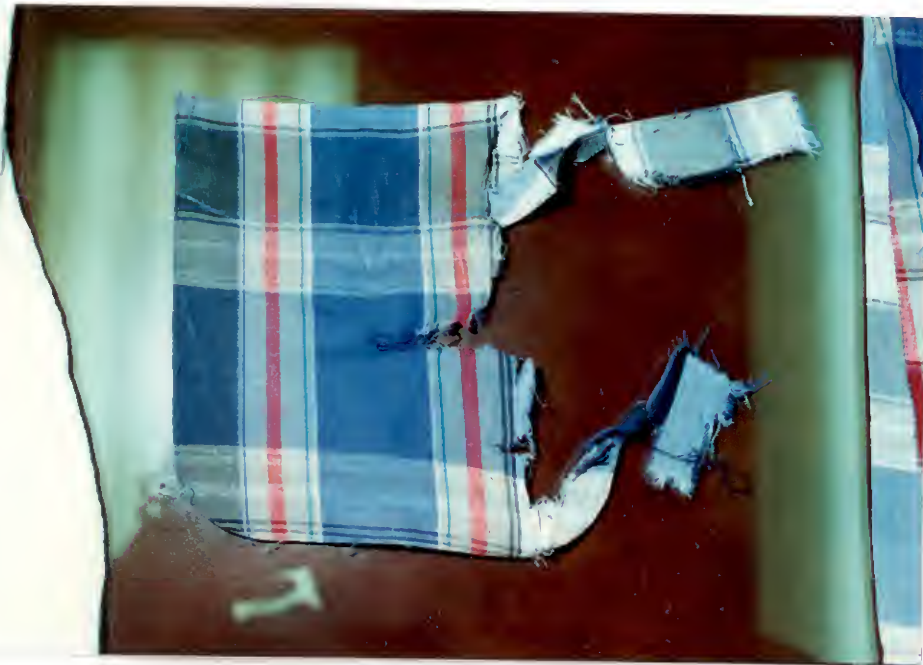
52. Separated right shirt pocket.

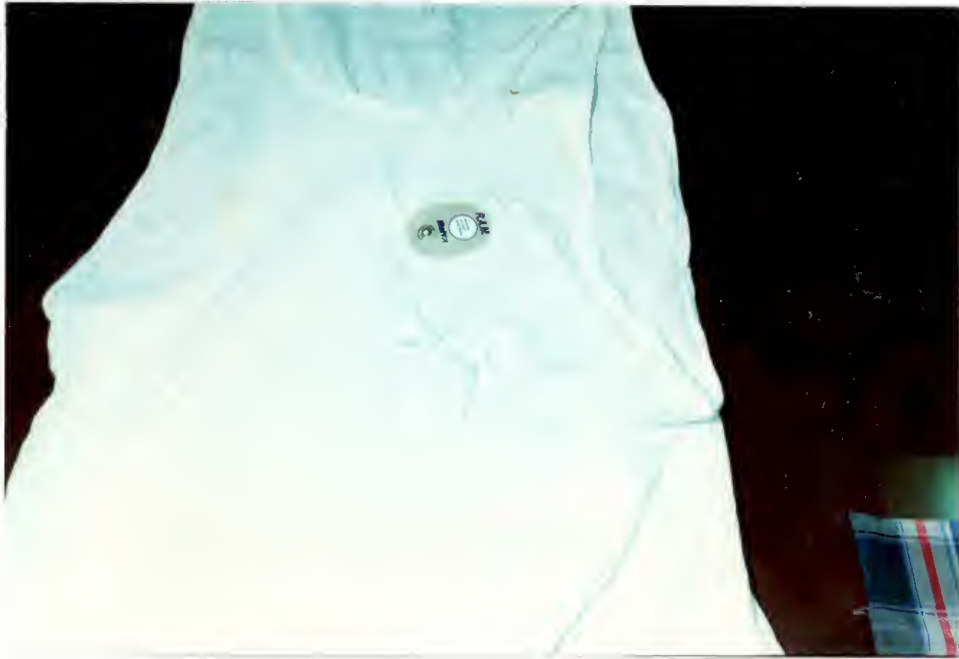
53. Tear of the driver's T-shirt at the left chest area.

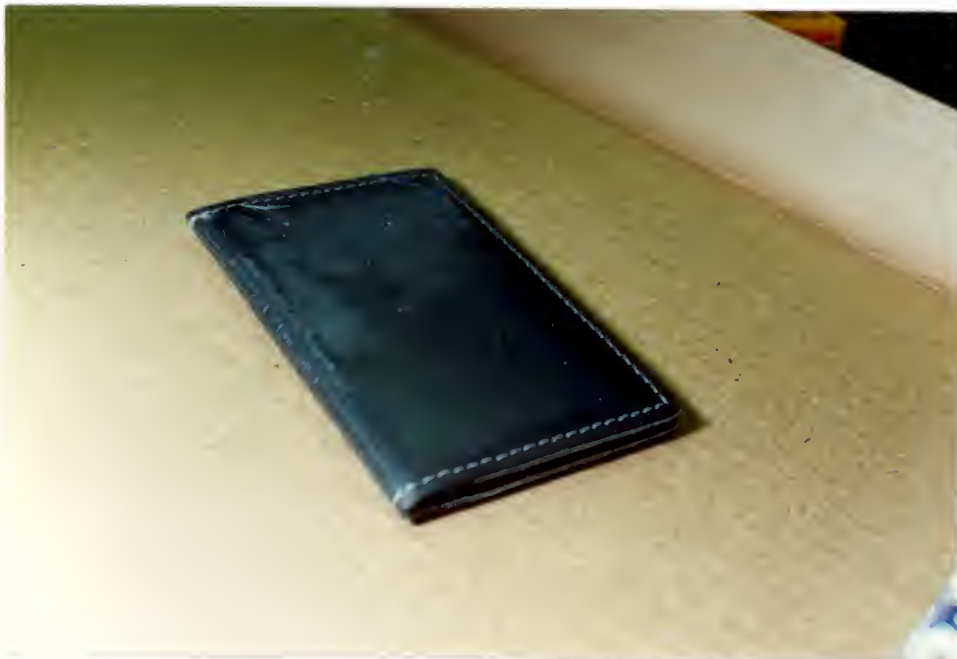
54. Air bag fabric transfers on the leather pocket calendar contained in the driver's shirt pocket.
